An Archaeological Assessment of  
The Pleasures Estate  
Sint Eustatius  
(SE 57)

By  
R. Grant Gilmore, III  
and  
Bradley D. Goodrich

St. Eustatius Archaeological Research Series, Number 10

Department of Anthropology  
May, 1998  
Revised April, 1999

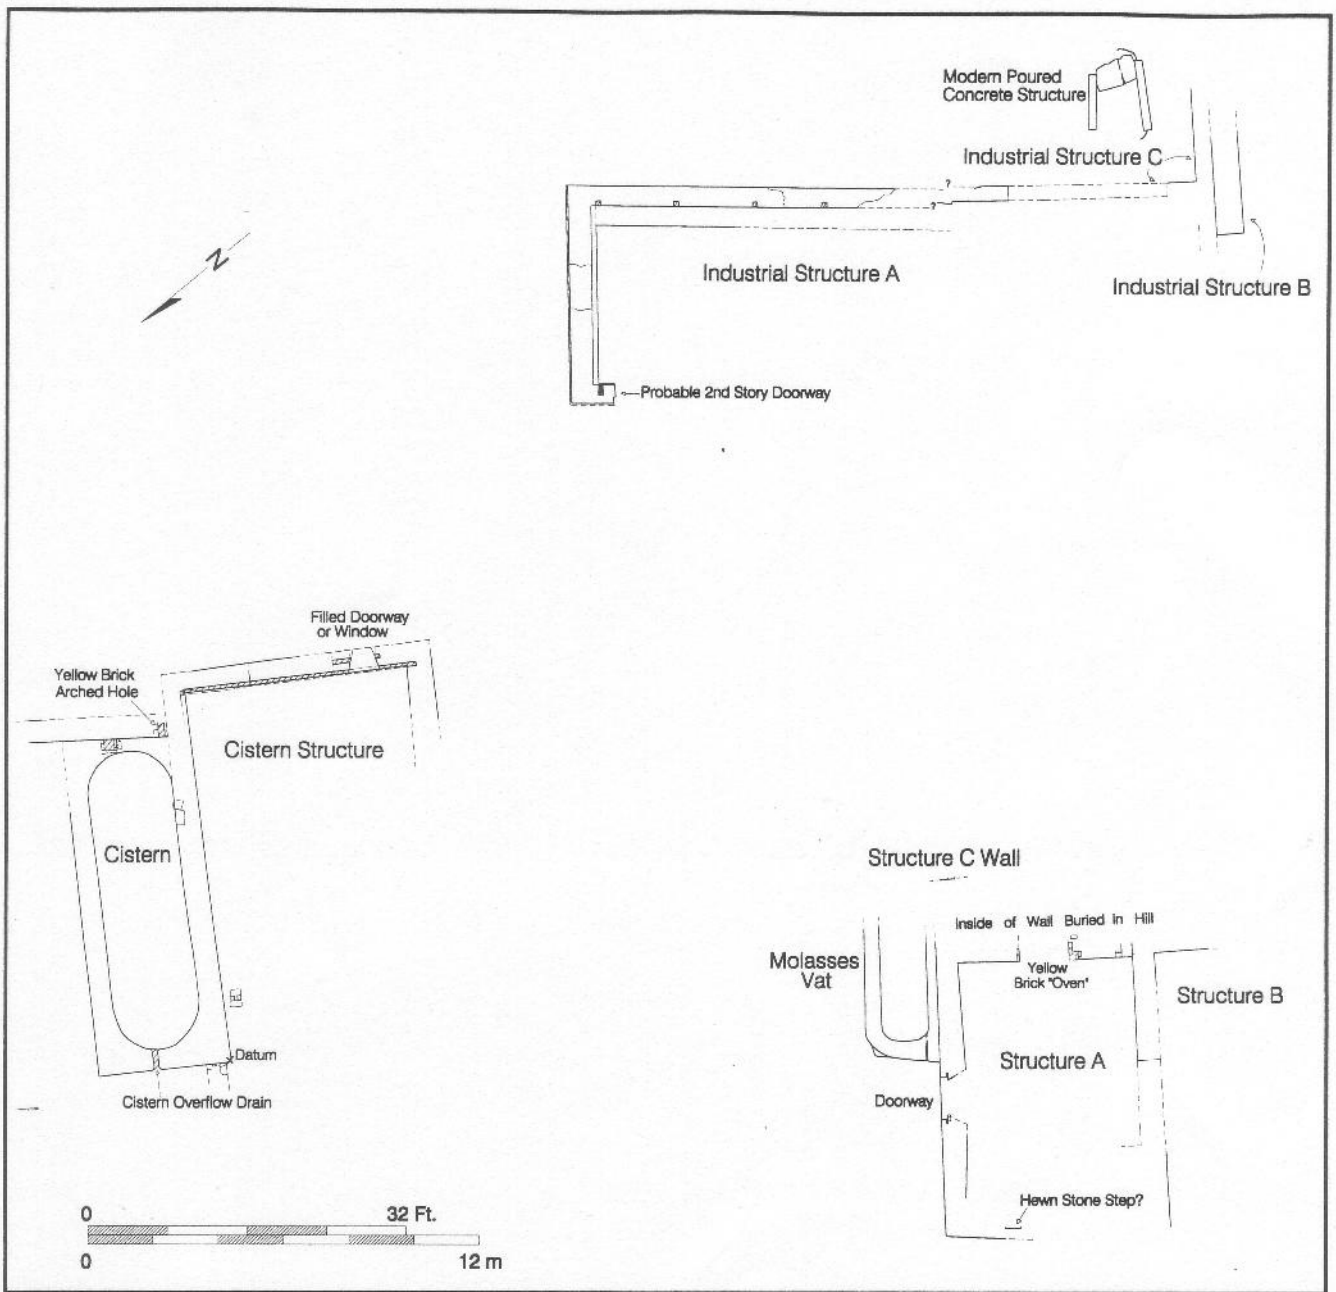
Figure 1. Site Map

Three structure complexes were identified after the vegetation was cleared from this site (Figure 1). These structure complexes are designated the "Industrial Complex," the "Large Cistern Complex," and the "Molasses Vat Complex." Each of these appeared at first inspection to be singular, distinct structures. Upon further investigation it was determined that each structure actually consists of at least two buildings each. The following are specific discussions of each complex.

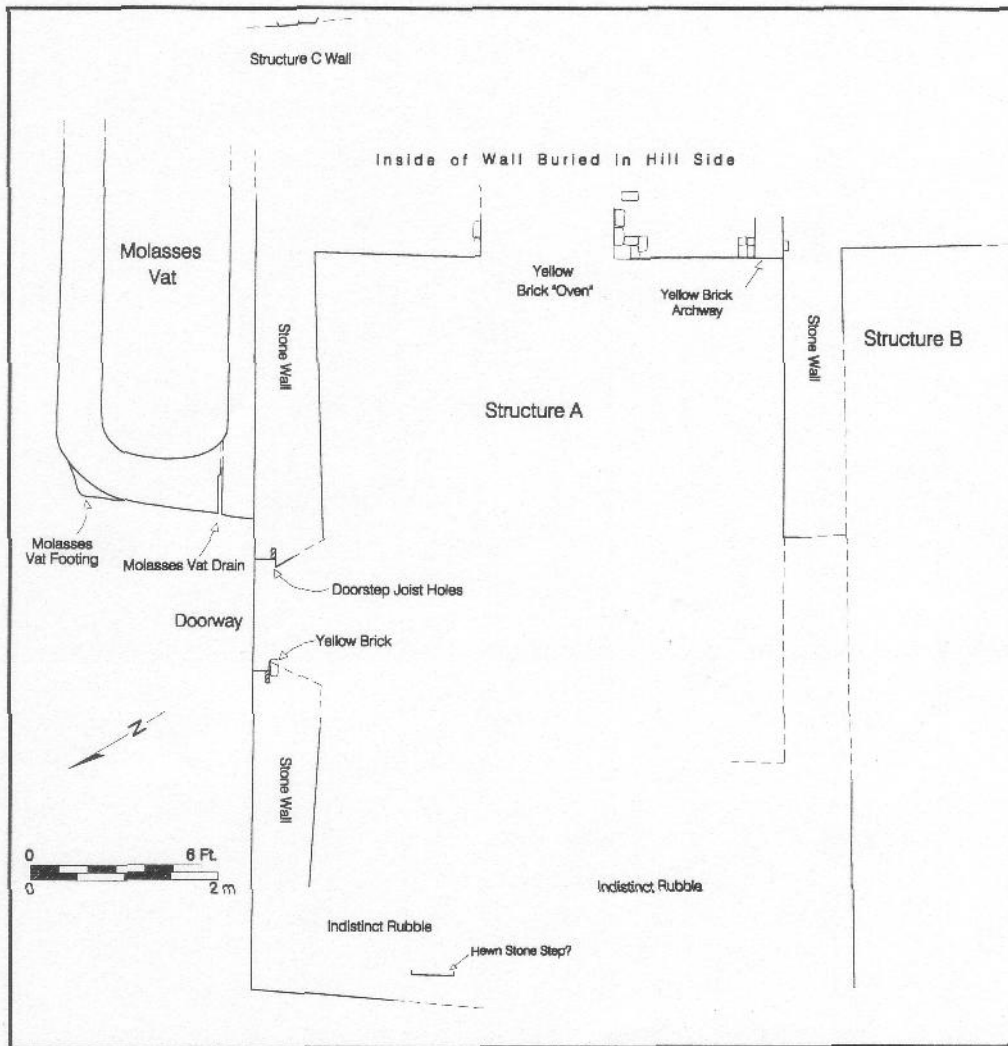
*Figure 4. Molasses Vat Complex*

Approximately 55 feet to the northwest downhill from the industrial complex is an additional complex of buildings. At this location there are two definite structures and a "molasses vat". (Figure 4) There is a very small portion of wall uphill from this area which is probably an additional building. The entire measurable complex is 30 feet northwest to southeast by 33 feet **northeast to southwest**. These structures may constitute a sugar curing facility.

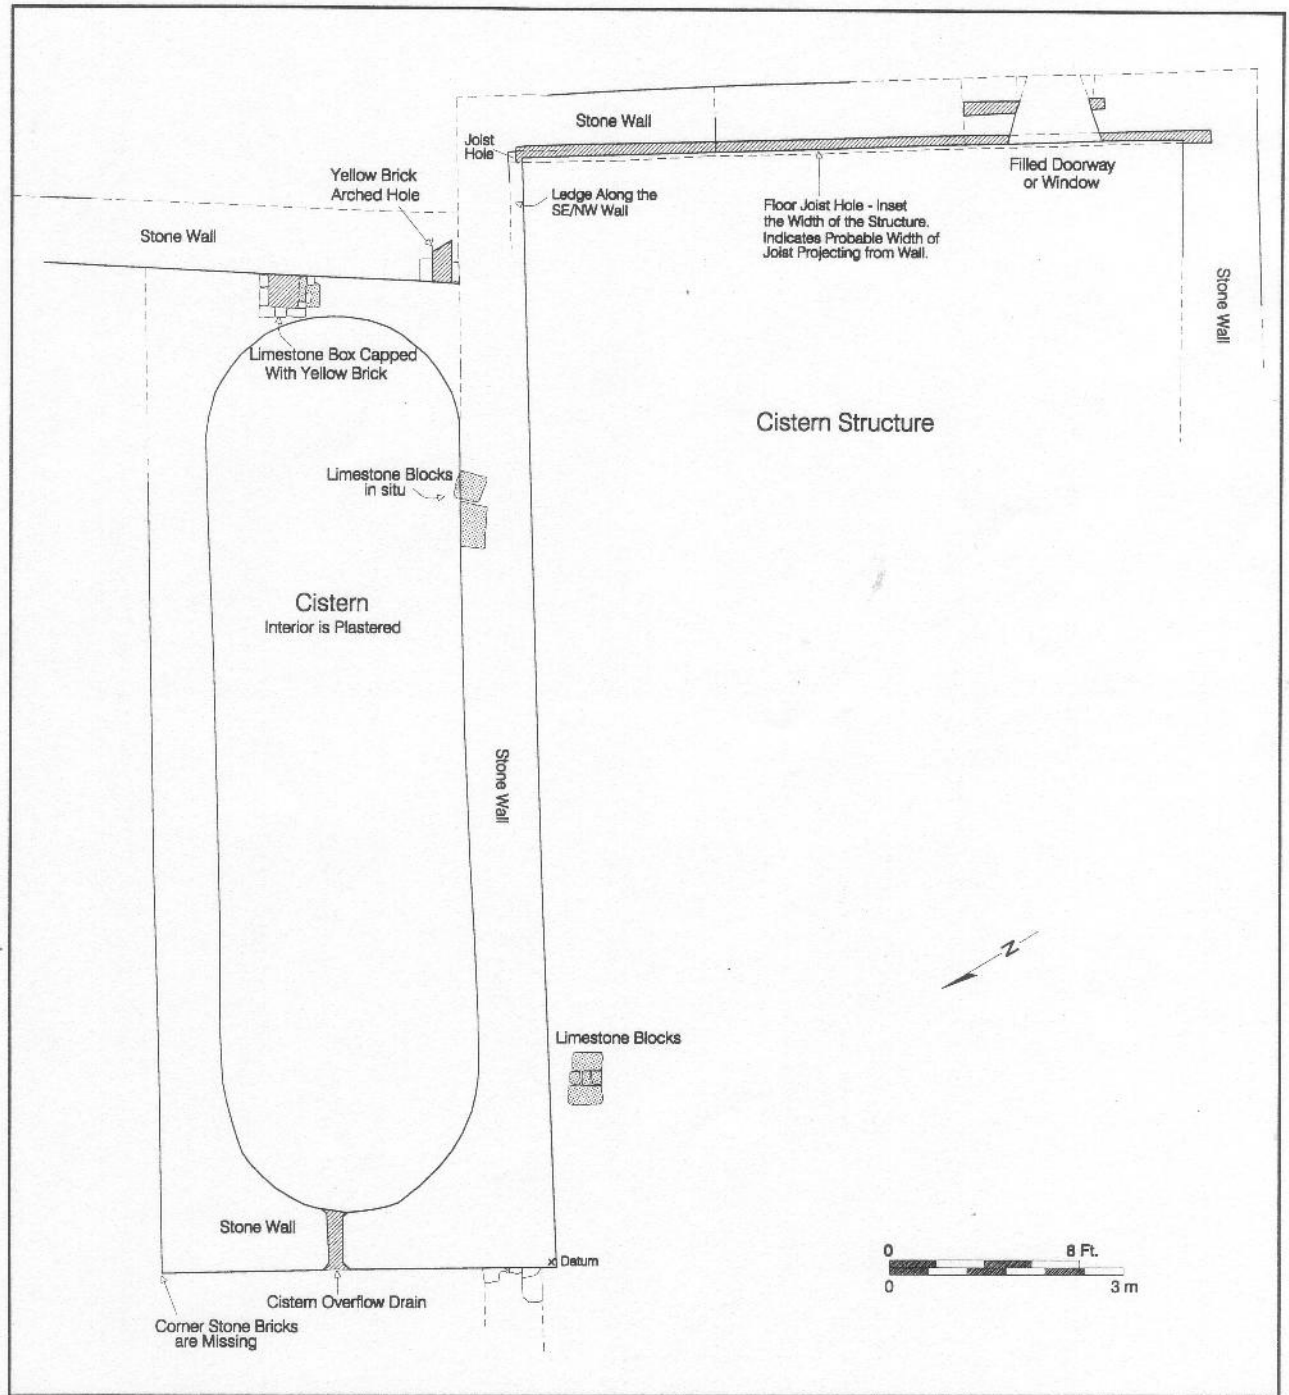
Figure 3. Large Cistern Complex

The Large Cistern Complex is located downhill from the Industrial Complex approximately 32 feet to the north (Figure 1). This complex consists of a large in-ground cistern, as well as the remains of several walls and features. The entire complex measures approximately 38 feet by 44 feet (Figure 3).
