# St. Eustatius Fort Oranje

SE-128

**A Historical Archaeological and Architectural Assessment**

12 July 2011

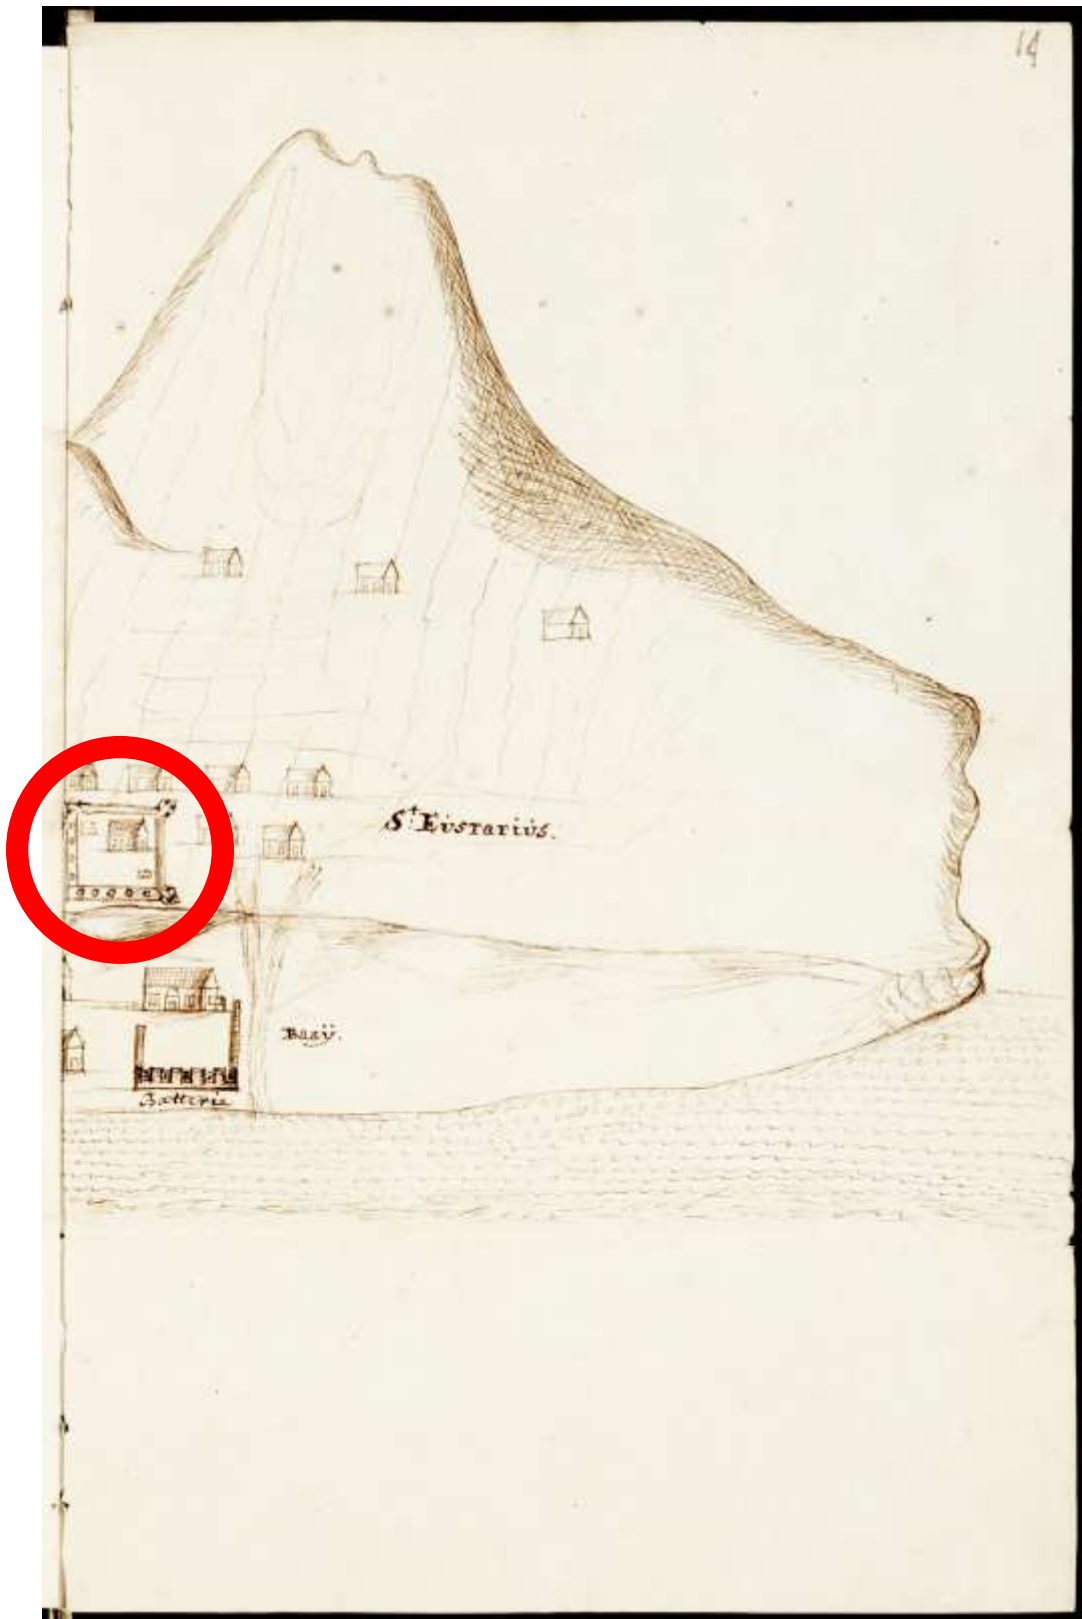
**Figure 2** 1723 depiction of the fortifications on St. Eustatius. The fort has two bastions, and is four sided.

There are few drawings of the fort that exist, and the earliest depiction we have of the fort is found on a map dating from 1723 (**Figure 2**). The fort seen in the cropped image is four sided, with two bastions. This image of the fort corresponds with early descriptions indicating a four sided Dutch fort pre-dating bastion Bockepunt falling off the cliff (Attema 22). Lamont does state in personal letters that the fort had four bastions, but this image only depicts two. It could be possible that Lamont is referring to the corners of the fort as bastions, or that two more

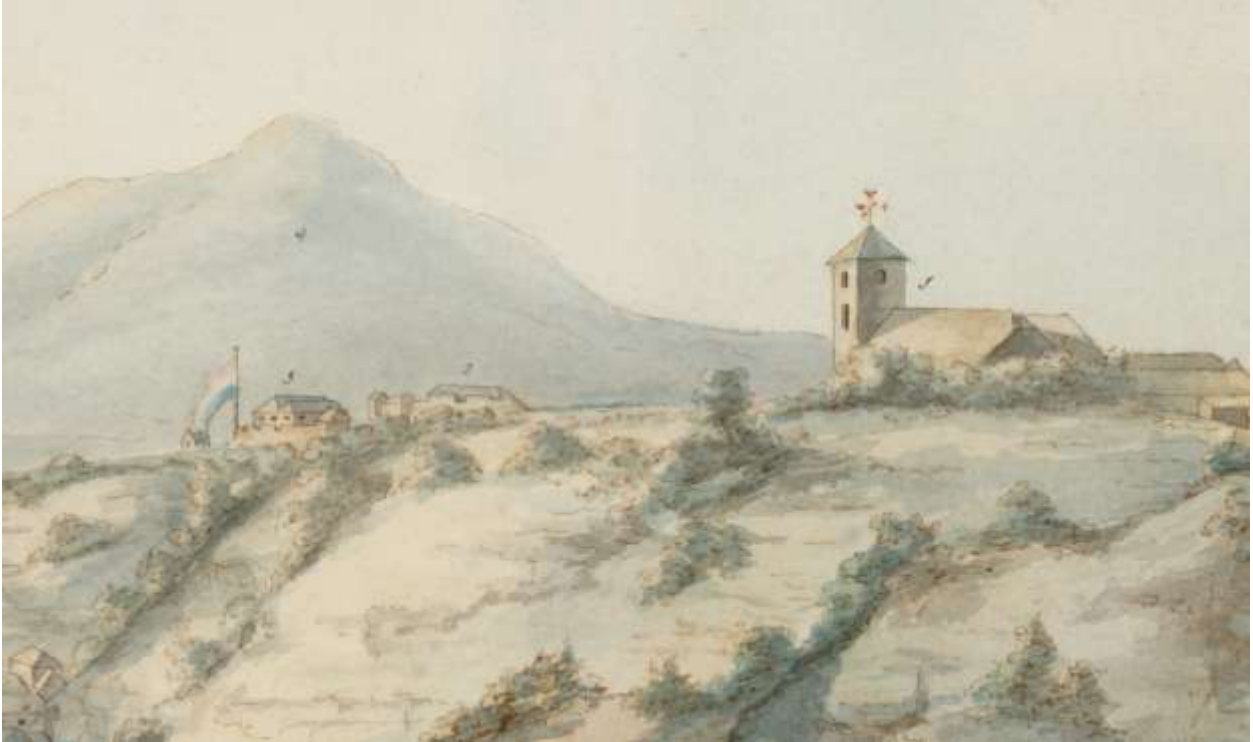
**Figure 3** Detail from a water color by A. Nelson (1774). Number two is Fort Oranje. There appear to be three corners of the fortifications shown in this picture.

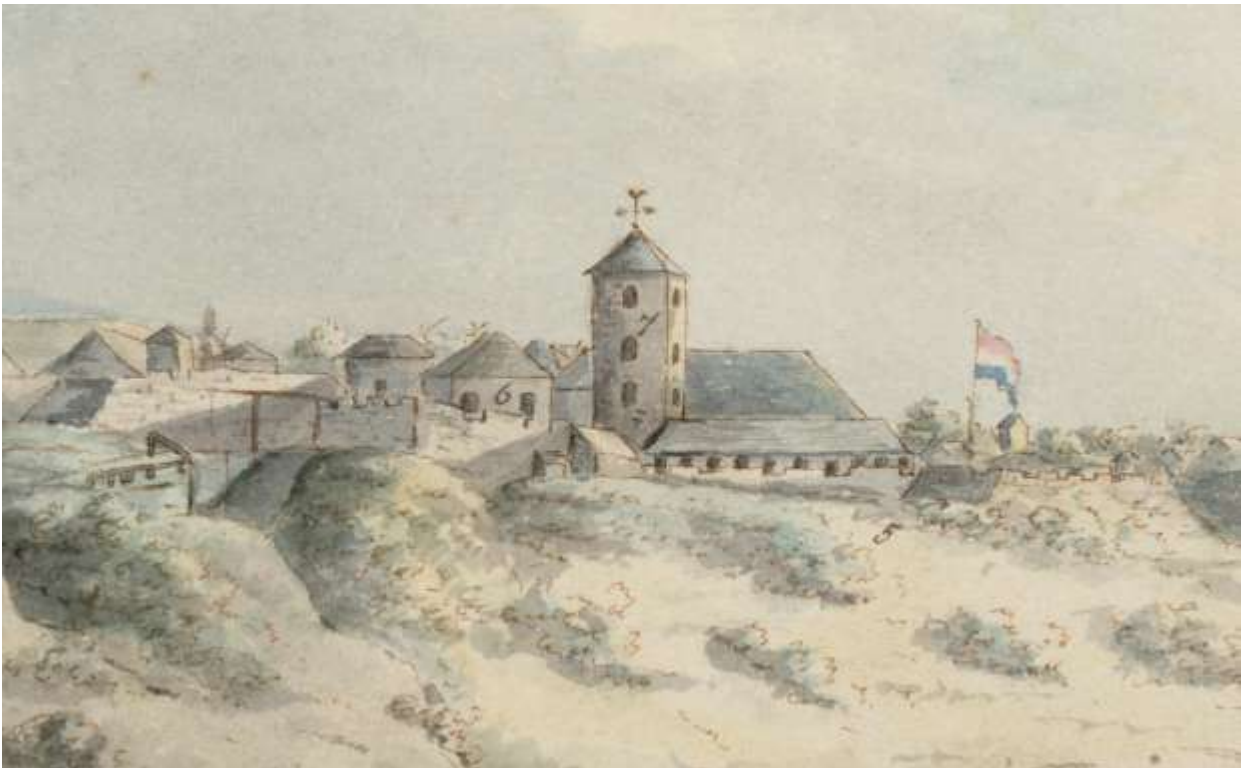
**Figure 4** Detail of Upper Town Oranjestad from A. Nelson Watercolor (1774). The number five depicts Fort Oranje and the number six depicts the government offices inside the fort.

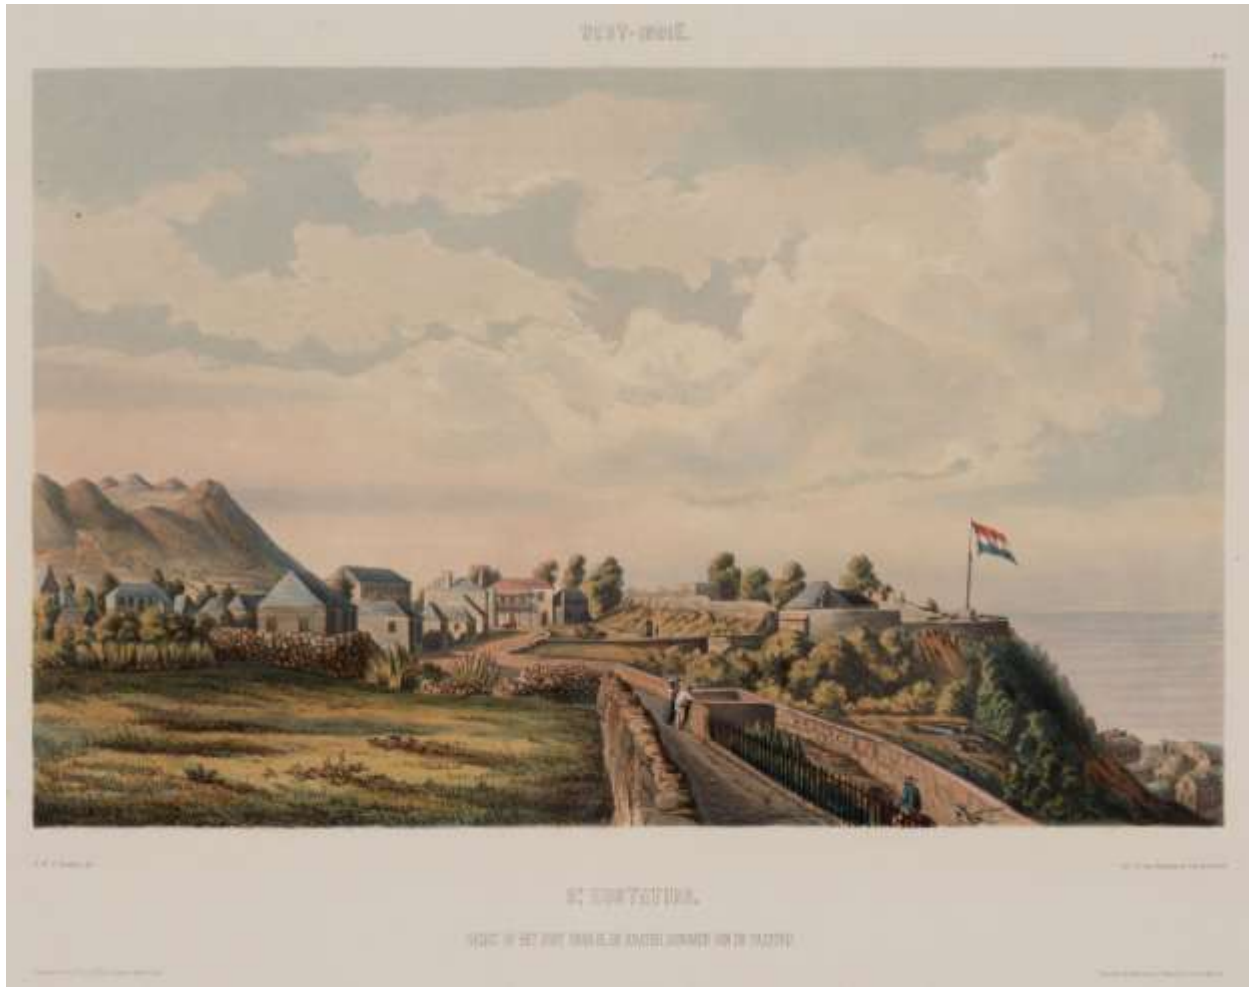
**Figure 7** View of the fort from Catholic Church by G.W.C. Voorduin (1860). The front entrance to the fort is visible, as is the roof over the former constable's house.

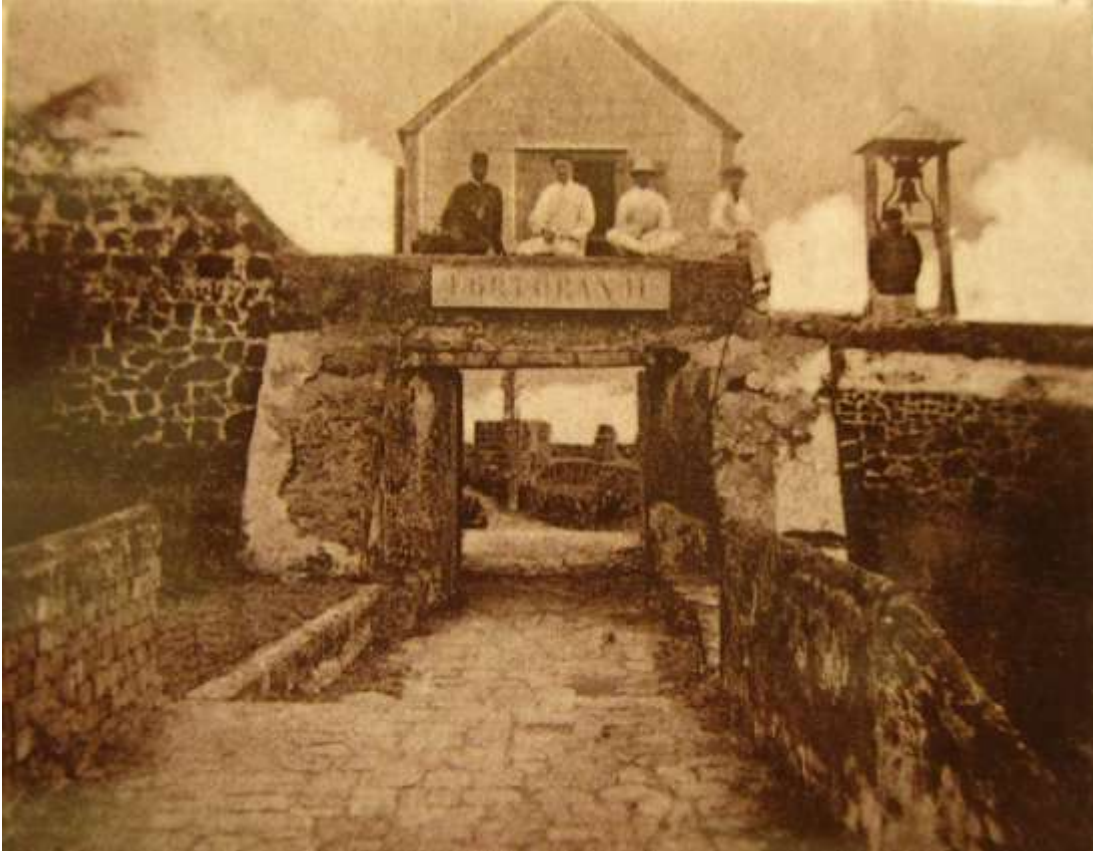
**Figure 8** Entrance to Fort Oranje before ca. 1912 (Unknown 1912). There is only one structure over the gate house, as opposed to the three seen in the photos from the fifties. The photo is from the private collection of Walter Hellebrand.

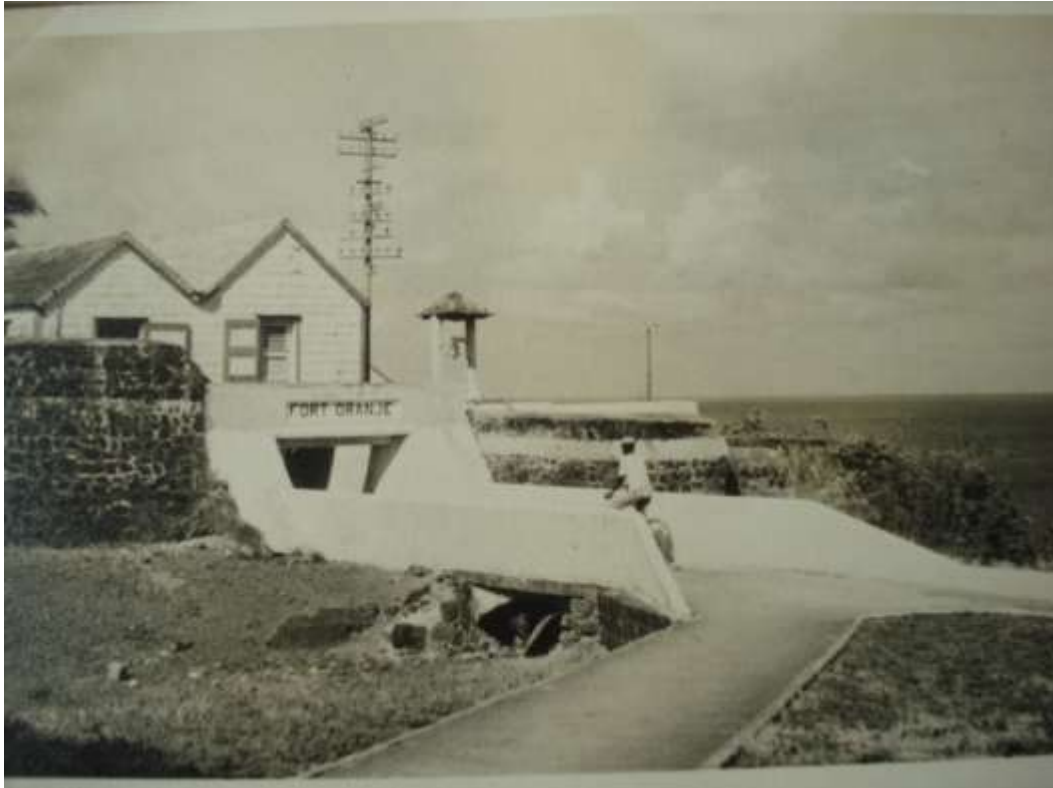
**Figure 10** Photo of Fort Oranje Entrance ca. 1940-50 (Unknown). The two structures over the entrance are the renovated Constable's house. The photo is from a private collection.

Later photographs dating from the nineteen fifties show that another structure has been added to the left of the gatehouse when facing the entrance gate to the fort (**Figures 10 & 11**). A wooden roof has also been placed to the right of the gatehouse, although the structure remains a single story (**Figure 10**). **Figure 11** shows the gatehouse from inside the fort. The walls of the foundation of the gatehouse have been painted or plastered over. The structures in the photograph are still present in the fort today.

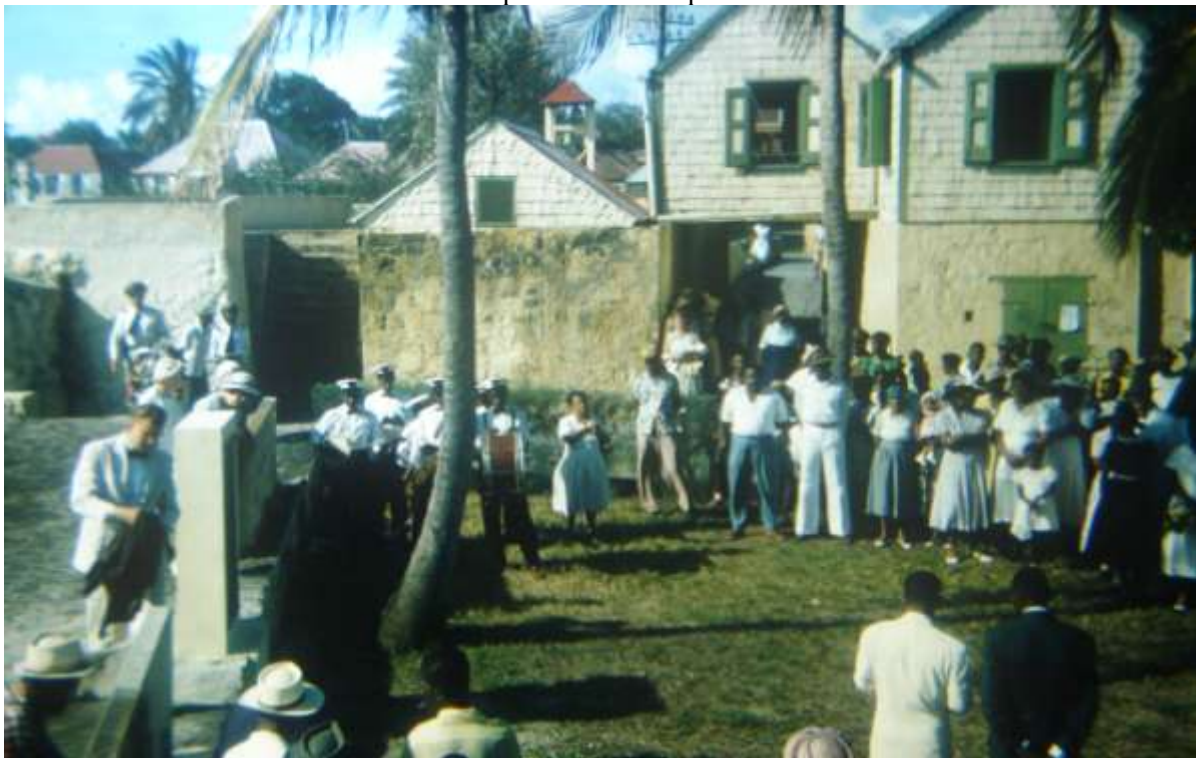
**Figure 11** Photo of the southside of entrance to Fort Oranje (Unknown 1950). The wooden structures are the constable's house, and the stone structures are the prisons underneath. The photo is from a private collection.
